Wind Turbine structural monitoring with Osmos Technologies

Summary

The capacity of the OSMOS structural monitoring system to respond to these questions by providing usable and conclusive information is illustrated by the following real case study of a wind turbine located in Greece. An example of the analysis and post-processing procedures of accidental impacts on the mast is briefly described below and concerns a strong dynamic event that was held on 16 November 2017.

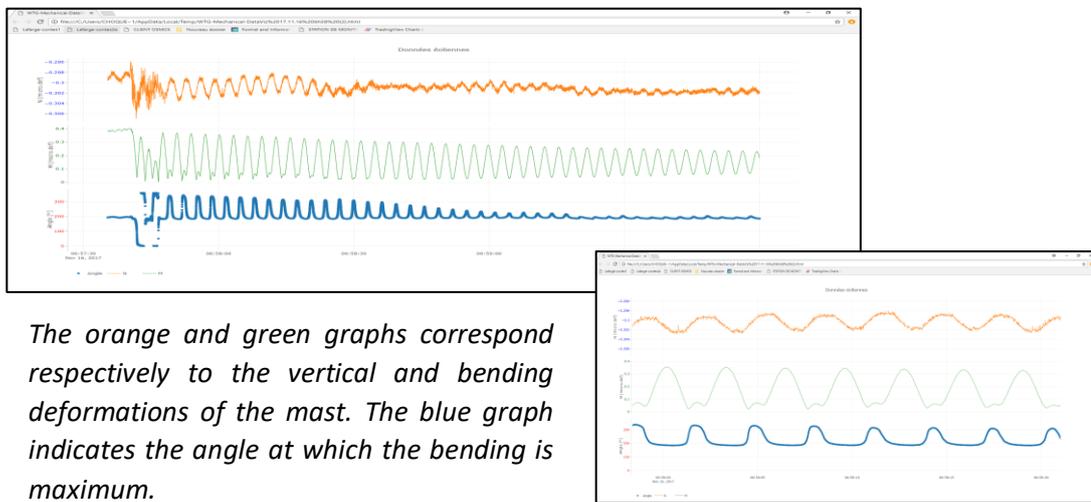
The single event below corresponds to a "Shut Down" of the machine. It was identified from intelligent statistical indicators that had abnormally high amplitude values compared to the normal behavior of the structure. Shortly after the start of the recording, the bending of the mast due to the action of the wind suddenly relaxed and the mast then began to oscillate freely.

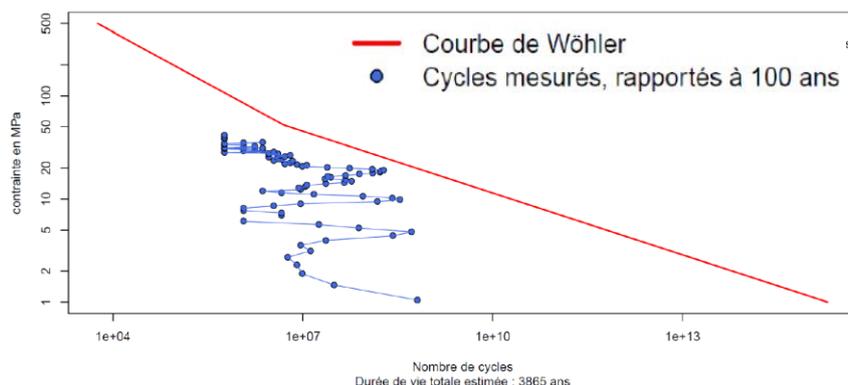
Damage cycle counting example

In the episode, the damage rate was higher than normal because the stress variations were repeated and of high amplitude. **When they are too frequent, these incidents have a major impact on the level of fatigue damage to the structure.**

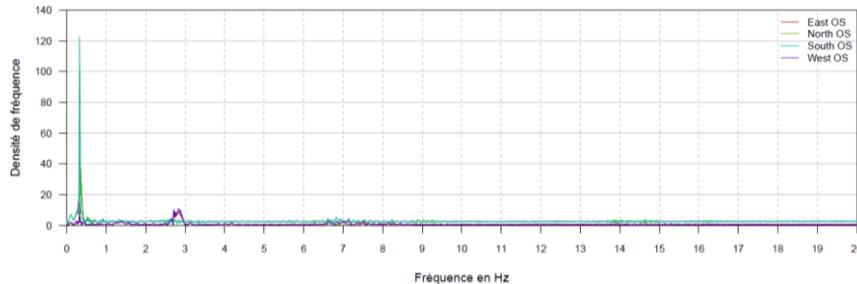
FFT : 1st Mode at 0.3Hz

The frequencies of the first natural modes are calculated by FFT (Fast Fourier Transform): 0.3 Hz for the first mode and 2.7 Hz for the second. These values are in accordance with those specified by the manufacturer.

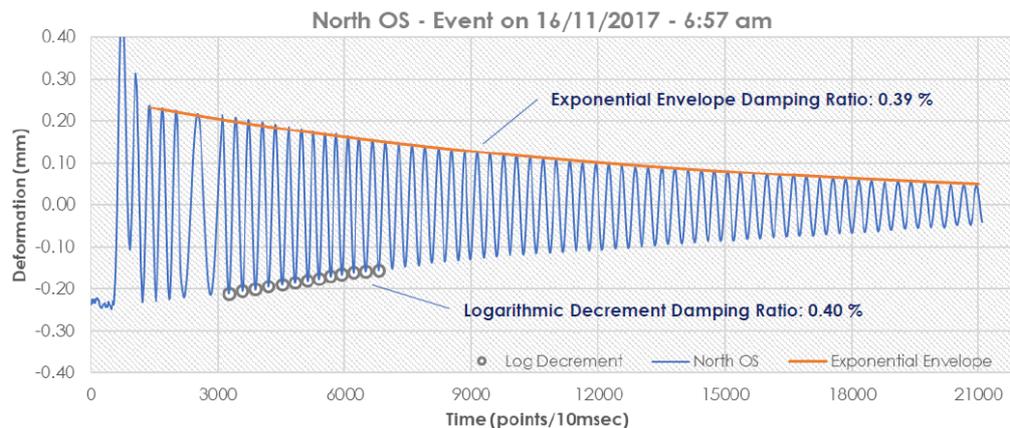
Damping coefficient calculation

In addition, the analysis of these measurements allows to calculate the actual damping coefficient* of the structure and compare it with the theoretical values taken in the calculation note. This valuable information can be used later to refine the assumptions made in the calculation notes.
